**Installation Restoration Program
Phase II - Confirmation/Quantification
Stage 1**

Seymour Johnson Air Force Base, NC 27531

July 1985

Prepared by
Center for Environmental Measurements
Research Triangle Institute
Research Triangle Park, NC 27709

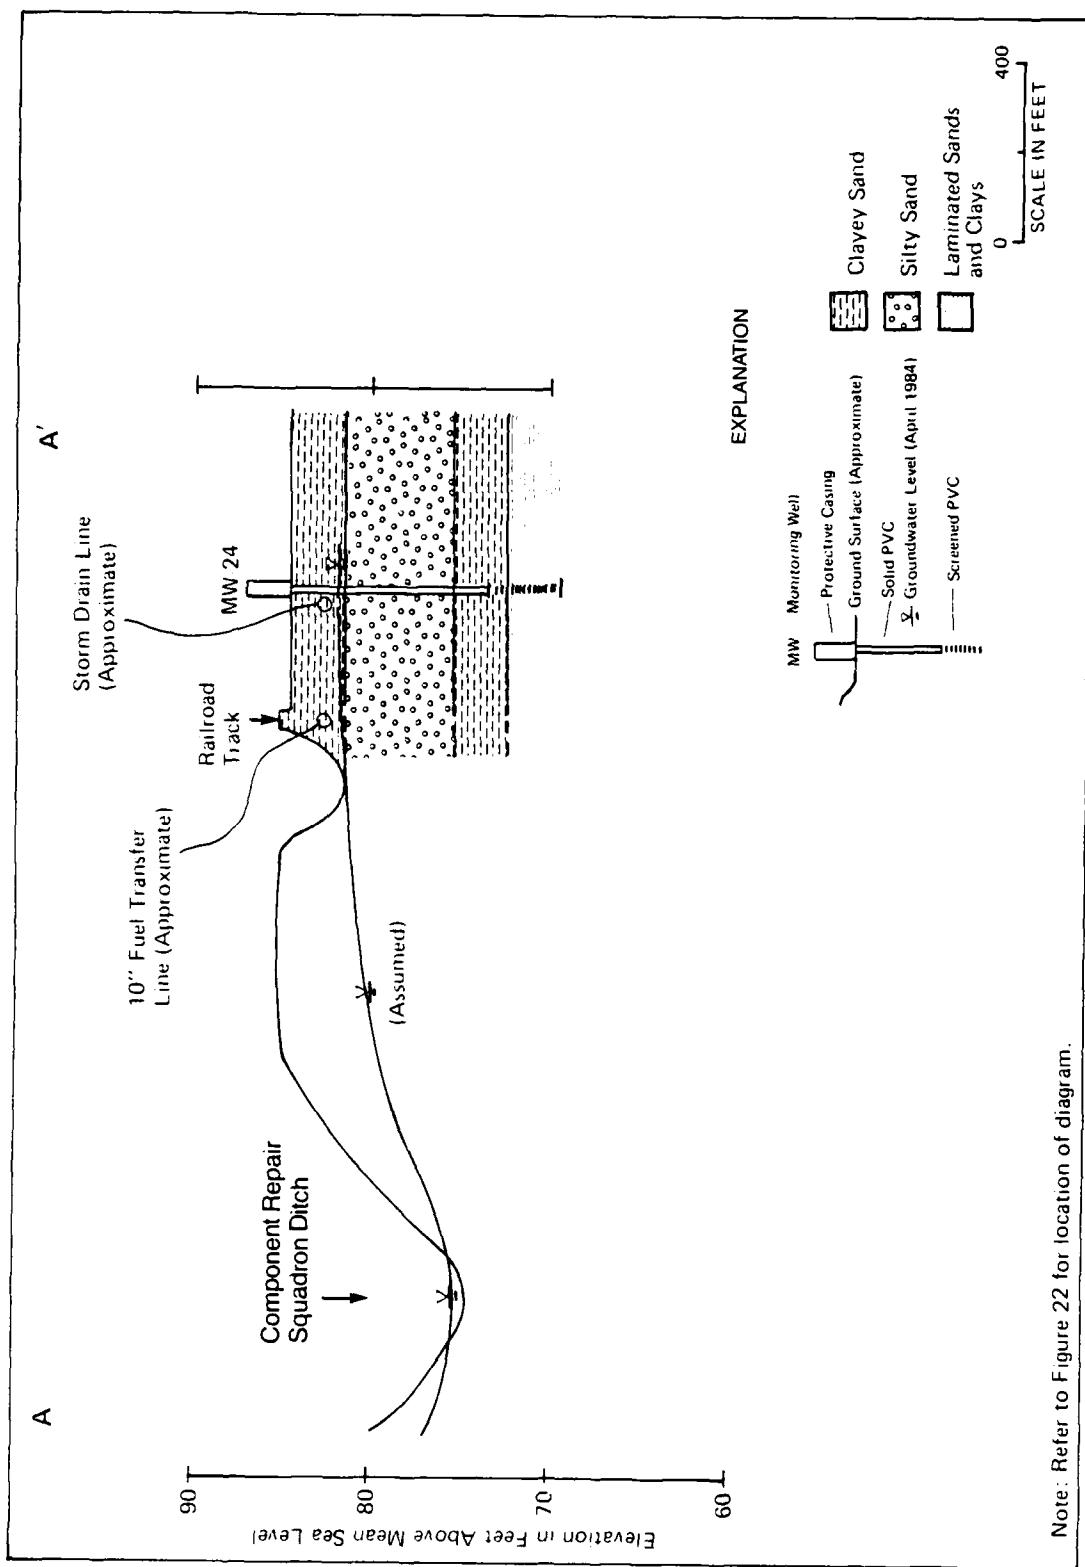
Figure 23. Schematic diagram of subsurface conditions (Site 3).

compounds than in the April samples. The concentrations of organic compounds are generally higher at Site 3 than at other sites studied on the Base and are indicative of petroleum-related compounds in the groundwater.

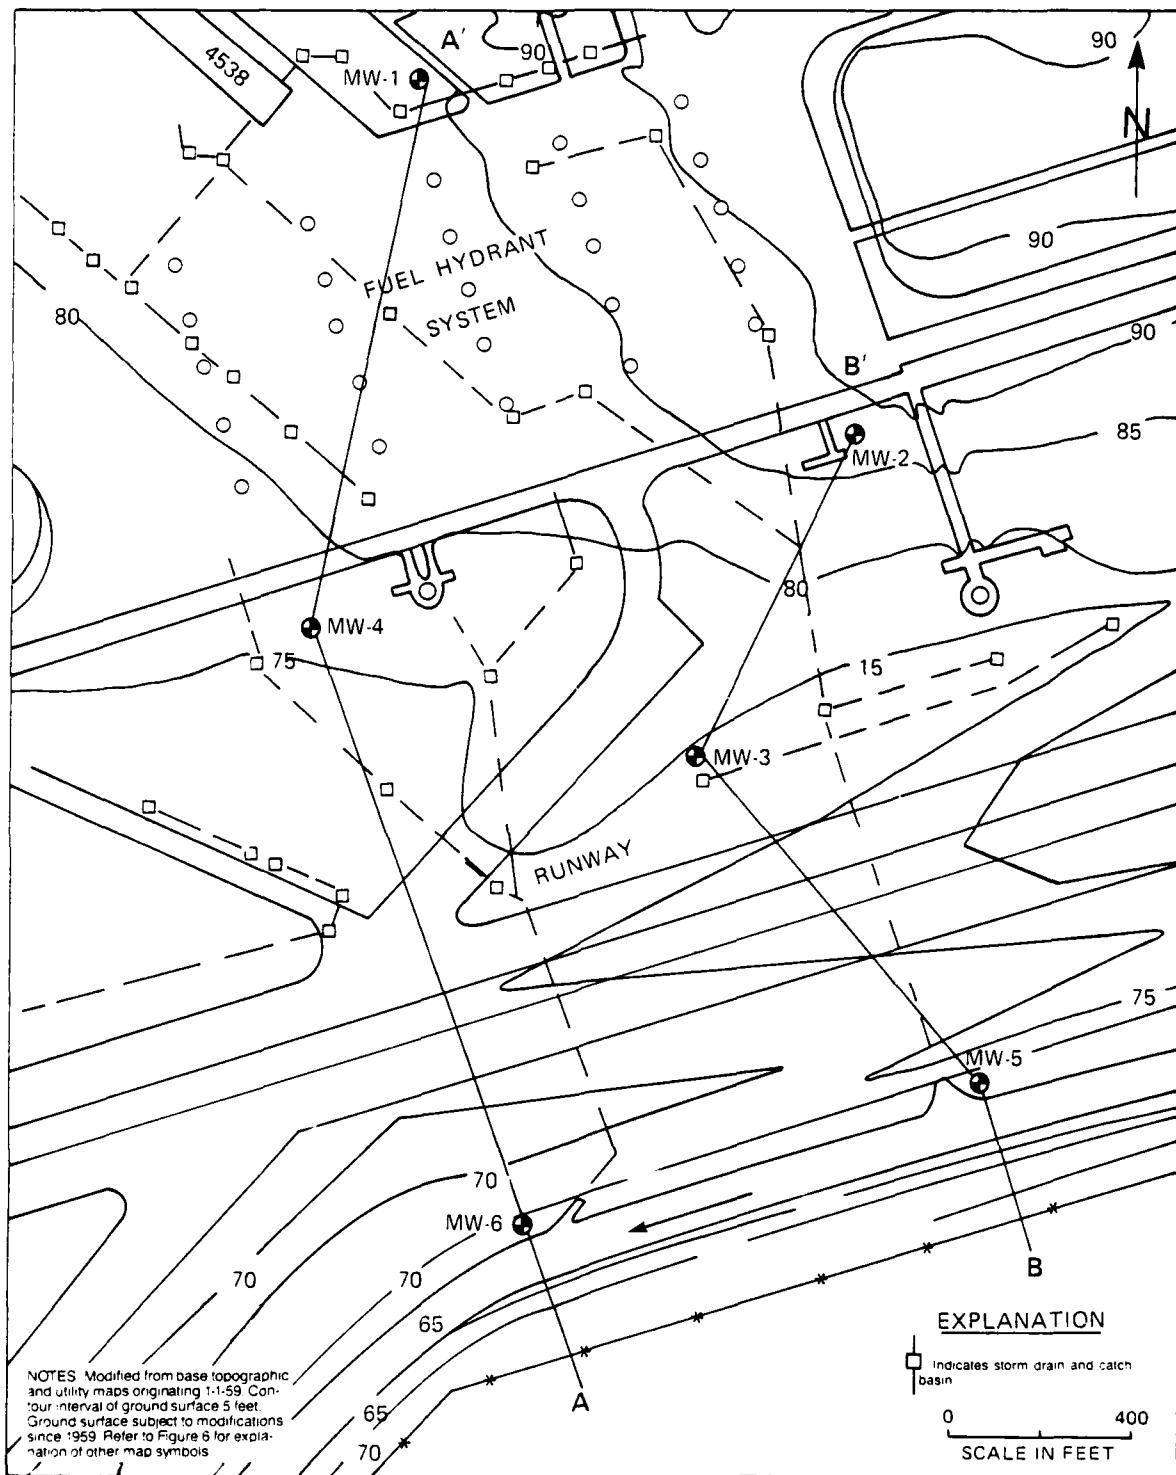
Figure 24. Topographic setting of Site 4 with location of inferred hydrogeologic profiles A-A' and B-B'.

The topographic setting of Site 4 is indicated in Figure 24 along with the location of two inferred hydrogeologic profiles. The site generally slopes to the south-southwest, with about 25 feet of relief. Major storm drains present in the area are also indicated on Figure 24. The storm drains discharge into the main southern-drainage ditch.

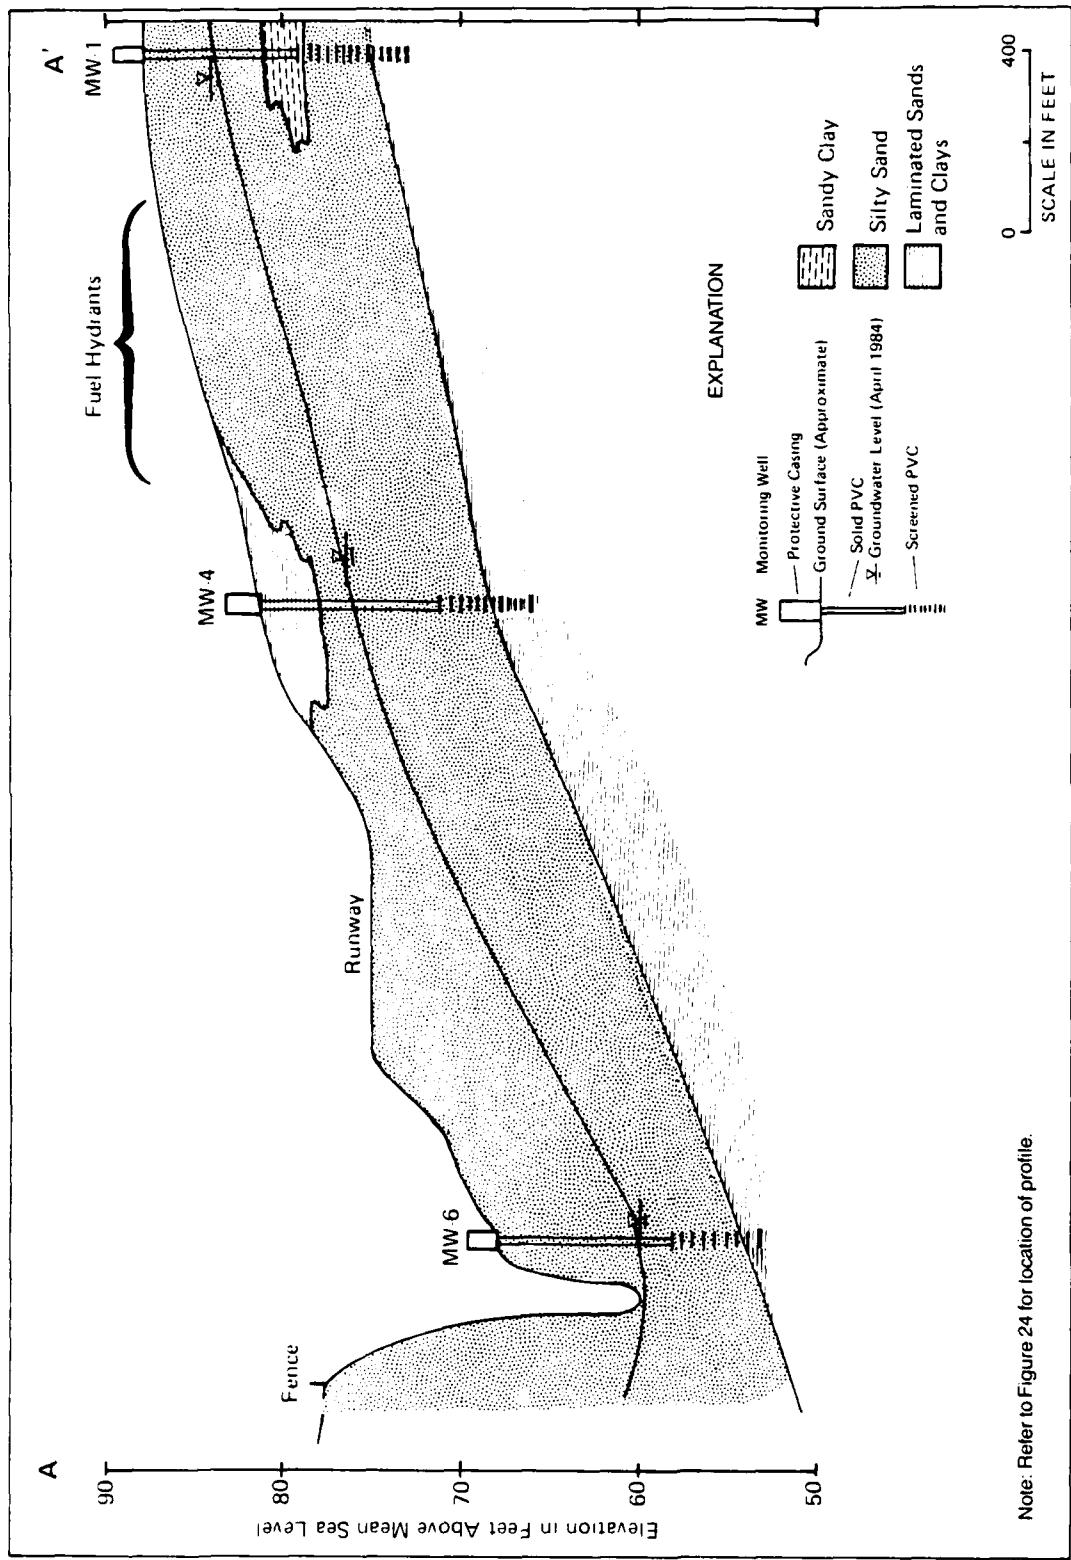
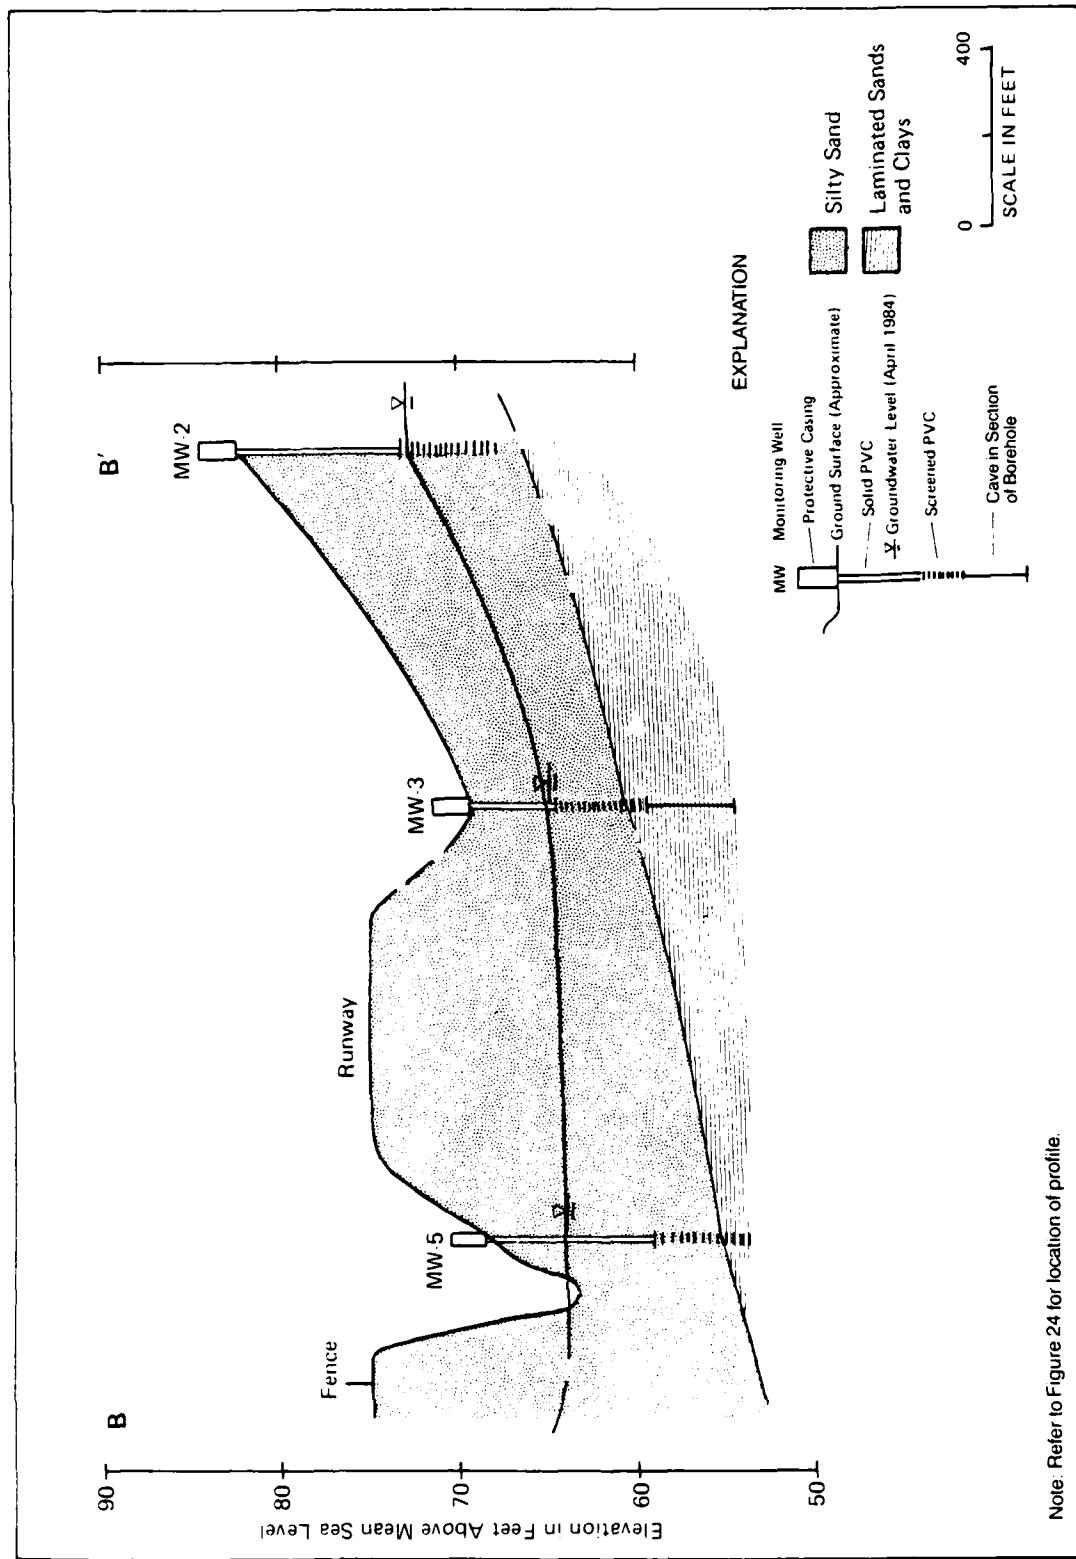
Six monitoring wells were installed at Site 4. Well MW-1 was intended to serve as a well upgradient of the fuel hydrant system, and the remaining wells were to serve as downgradient wells. The two parallel hydrogeologic profiles at the site (Figures 25 and 26) are based on subsurface conditions encountered in these wells. The conditions encountered are similar as seen by comparison of the profiles.

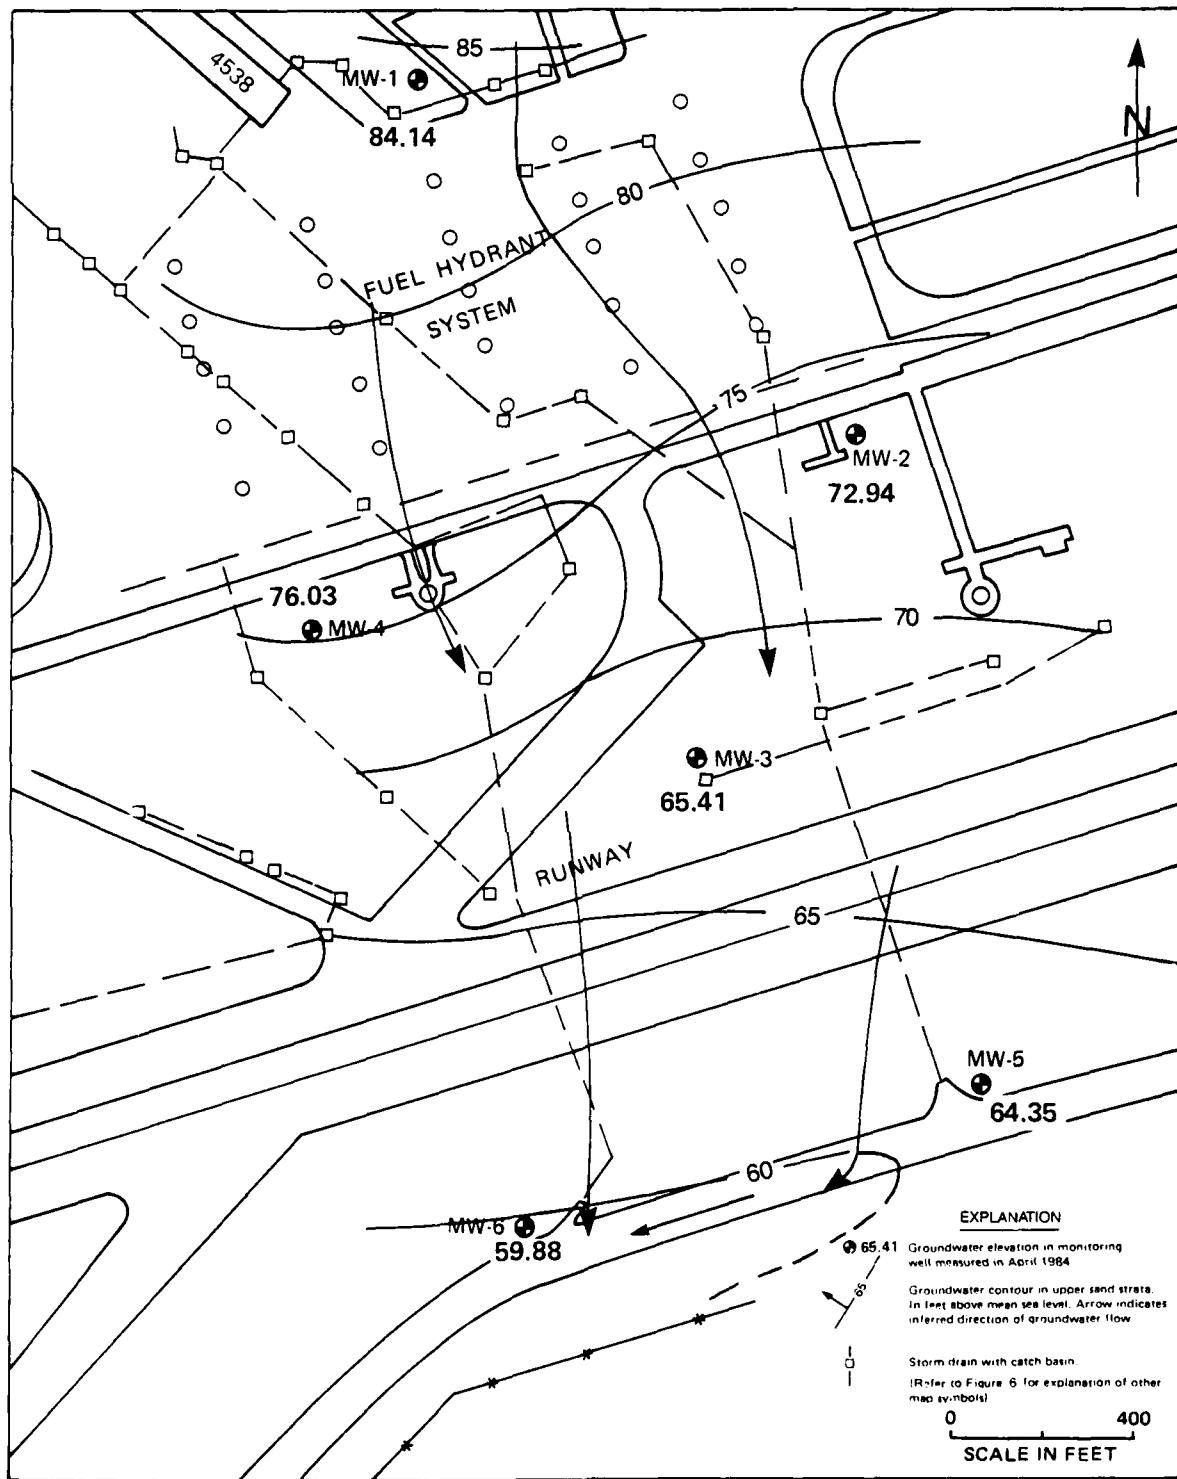
Figure 27. Groundwater elevations at Site 4 with inferred direction of flow in upper sand strata.

The upgradient well was noted to have a higher specific conductance (155 to 170 $\mu\text{mho}/\text{cm}$) and pH (5.95) than the range of values measured in the field for downgradient wells (specific conductance of 39 to 81 $\mu\text{mho}/\text{cm}$) and pH 4.1 to 5.85). No other unusual observations were noted of water quality conditions in the field except a hydrogen-sulfide-like odor of the groundwater in well MW-4 during development (Appendix F).

The results of water quality analysis for Site 4 are provided in Appendix H, Table H-4. The total organic carbon was elevated in wells MW-4 and MW-6 (10.1 and 11.0 mg/l, respectively). The concentration of oil and grease was elevated in wells MW-3 and MW-6 (1.26 and 1.52 mg/l, respectively).

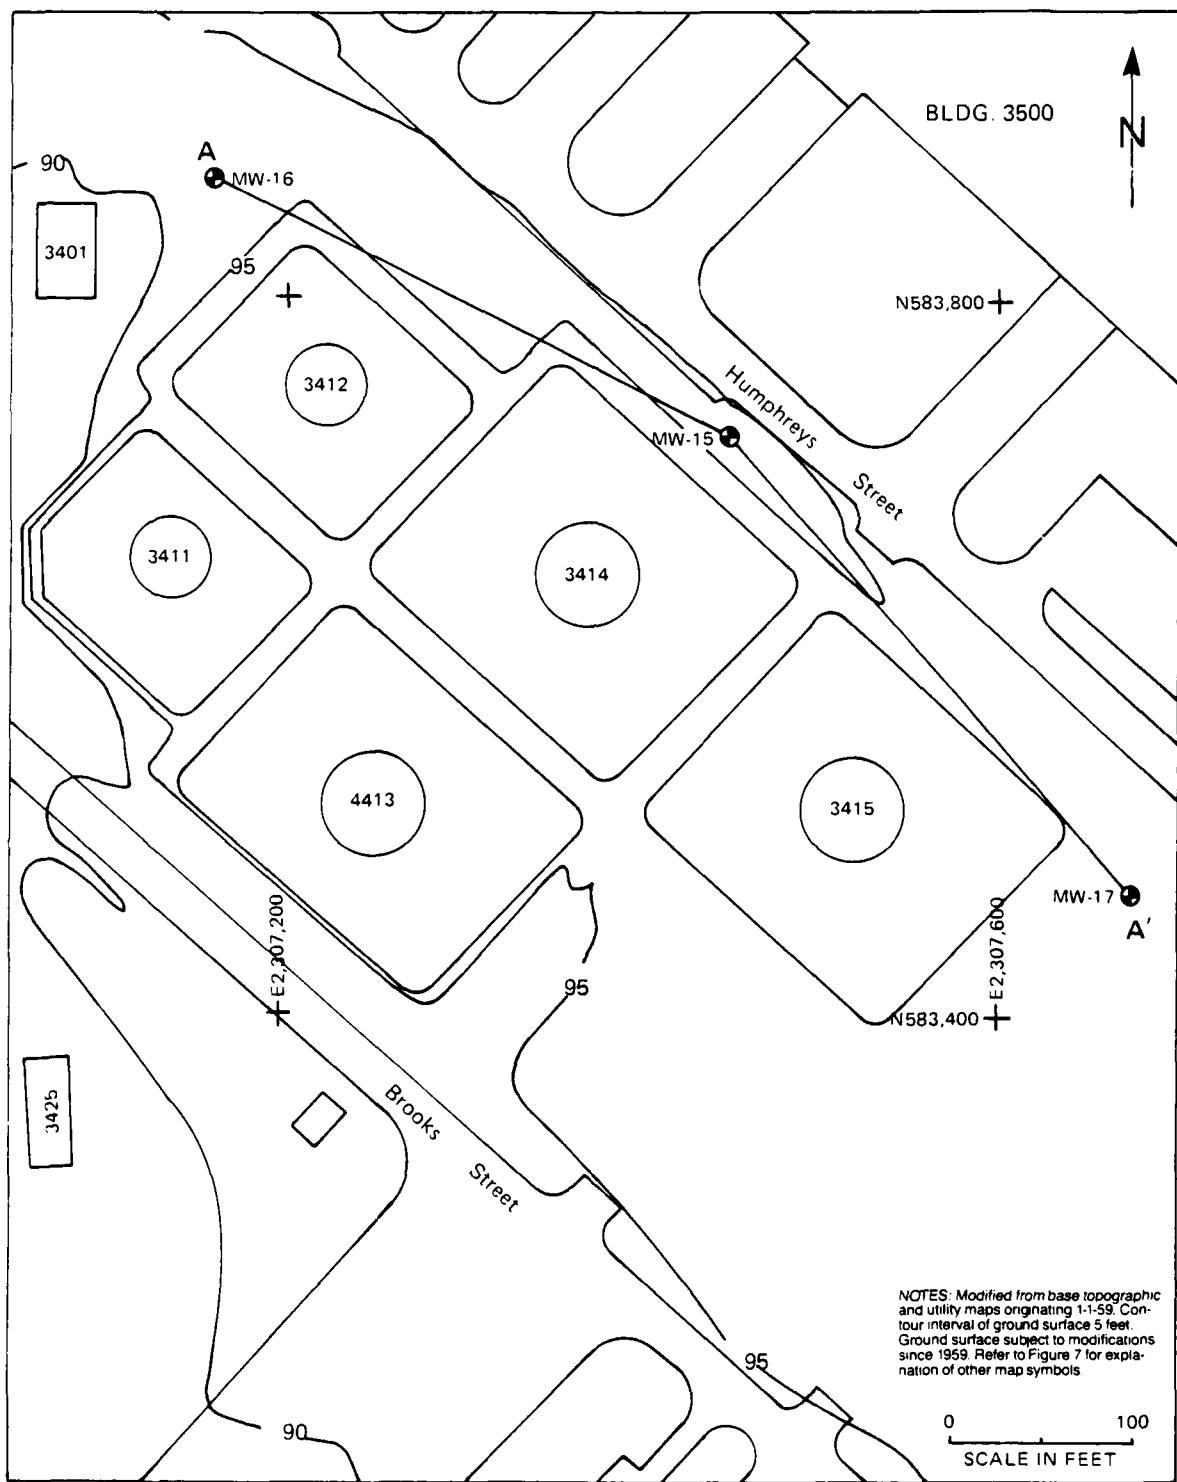
Figure 28. Topographic setting of Site 5 with location of inferred hydrogeologic profile A-A'.

The general topographic setting of Site 5 is indicated in Figure 28 along with the location of an inferred hydrogeologic profile. The top elevation of the tank farm dikes is around 95 feet above msl, and the site slopes slightly toward the POL yard to the west-southwest.

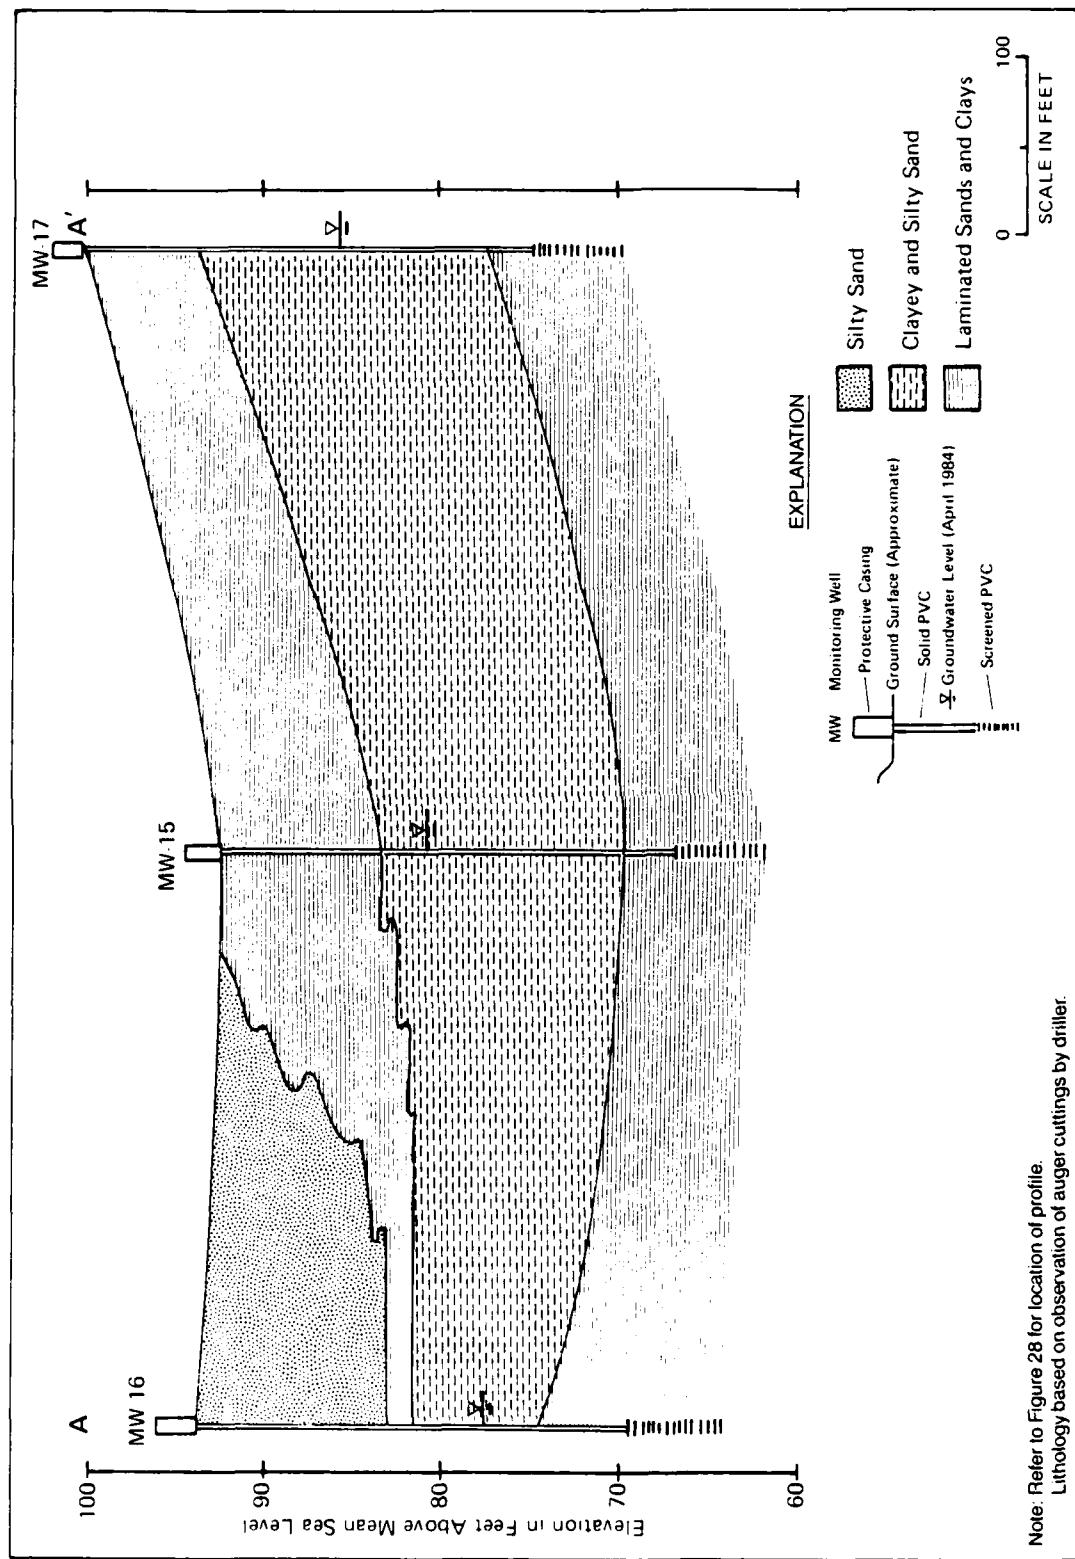
Figure 29. Inferred hydrogeologic profile A-A' (Site 5).

The lithology beneath wells MW-15 and MW-17 is similar (Figure 29). About 7 to 10 feet of silty clays overlie 12 to 15 feet of clayey and silty sands. MW-16 differs in that silty sands occur within the upper 10 feet according to the driller's descriptions. These sand strata were encountered in all three monitoring wells and overlie a gray silty clay stratum, probably representing the Black Creek formation. All three wells are screened within the Black Creek formation.

Well yields of MW-15 and MW-16 were less than 1 gal/min (Appendix F) and were consistent with wells at other base sites screened within the Black Creek formation. Well MW-17 had the highest yield of the monitoring wells on Base (15 gal/min) and is not representative of wells screened within the upper clayey section of the Black Creek formation. The screened and gravel-packed section of well MW-17 most likely has a direct hydraulic connection with the overlying sand strata or could be in a more permeable zone not detected in the auger cuttings by the driller.

In April 1984, groundwater was encountered at depths of 10.93 to 15.45 feet below the land surface of the site. Water levels had risen 0.4 feet in wells MW-15 and MW-17 since February but had declined 1.75 feet in well MW-16 (Appendix E). Groundwater elevations measured in April 1984 tend to indicate flow from MW-17 toward MW-16 (Figure 29). Higher groundwater elevations may exist within the overlying sand strata, but additional monitoring wells would be needed to assess the different flow components.

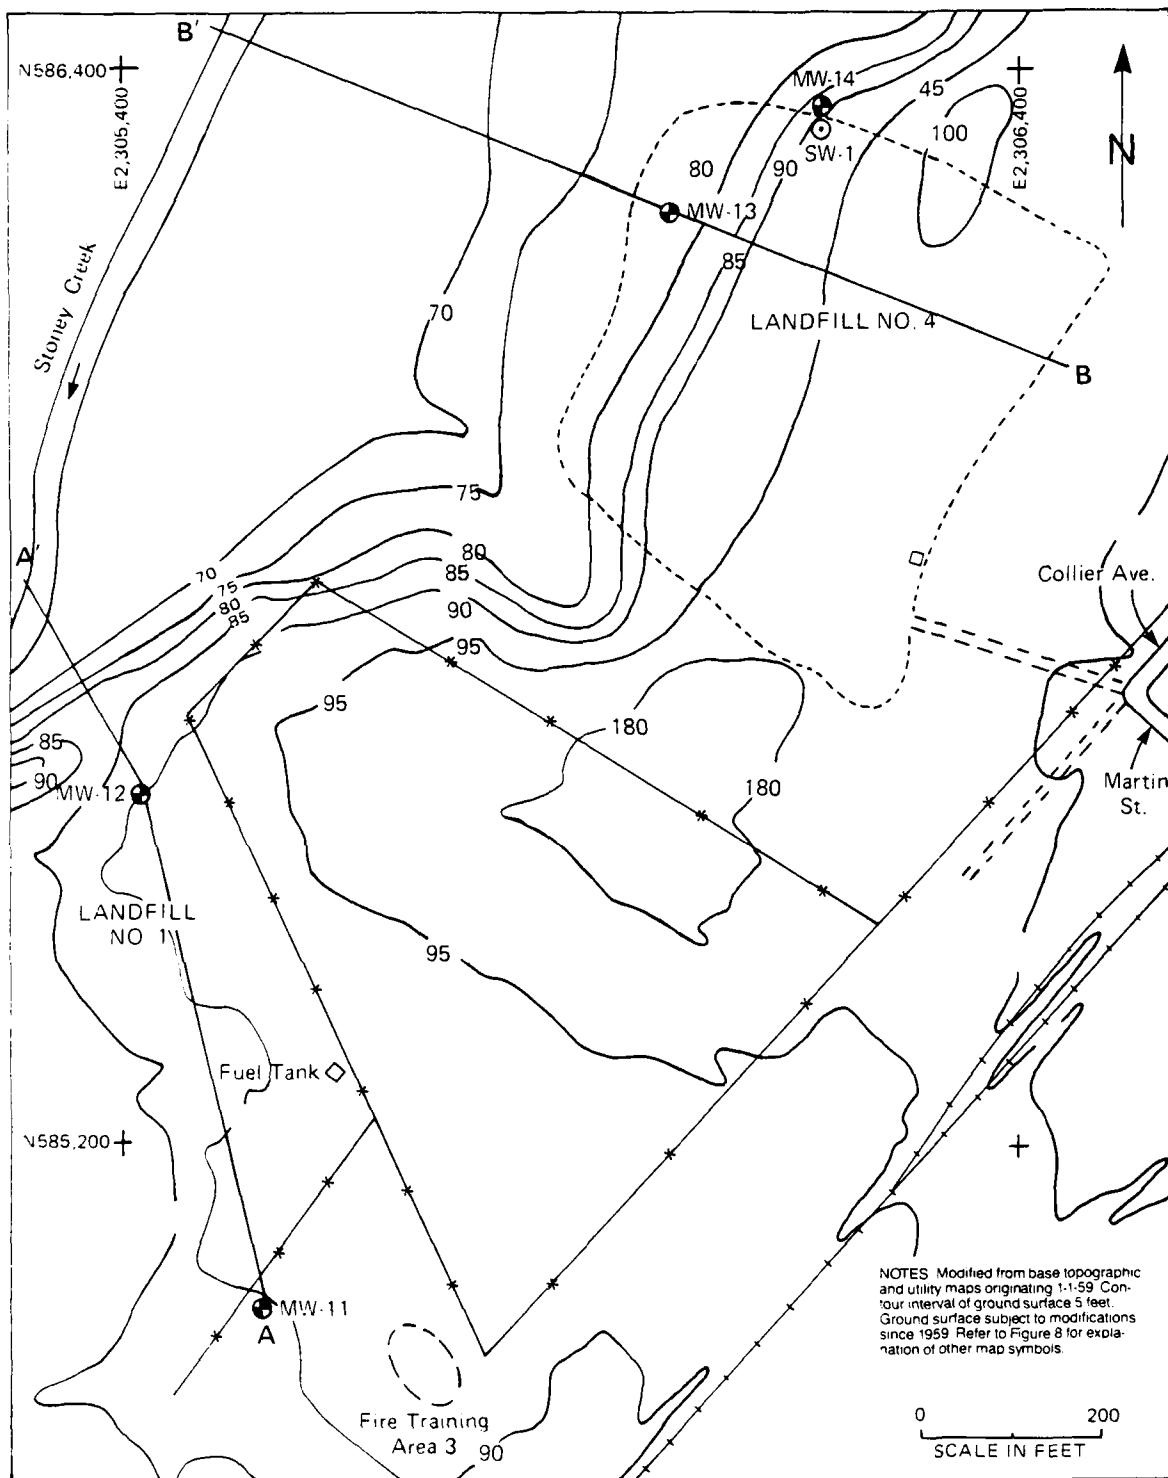
Figure 30. Topographic setting of Site 6 with location of inferred hydrogeologic profile A-A' and cross section B-B'.

The general topographic setting of the fire training area is indicated in Figure 30 along with the location of an inferred hydrogeologic profile. The immediate site area is fairly level but beyond the nearby fence it begins to slope to the northwest toward Stoney Creek.

One monitoring well (MW-12) was installed between the assumed northern limits of the landfill and Stoney Creek (Figure 30). A relatively thin scattering of rubble fill material was observed in the vicinity of MW-12.

Two monitoring wells (MW-13 and MW-14) were installed at the landfill. One seepage sample (SW-1) was also collected from a leachate migrating from the northern toe of the landfill (Figure 30). The boring used to construct well MW-13 was drilled directly through the landfill material. Fill material consisting of wood fiber, glass, plastic, paper and some clayey, sandy soil was encountered from the land surface to a depth of about 18 feet (Appendix C). The sample from 18 to 20 feet was not recovered but is assumed to be loose saturated sand or gravel near the water table. Silty sands with well-rounded pebbles were encountered to the termination of the boring at 25 feet. Well MW-14, not placed in the landfill, encountered multicolored silty sands and pebbles from land surface to a depth of 5 feet. Gray silty fine sand laminated with dark gray silty clay underlies the sand strata at MW-14 (Figure 32) and is assumed to represent the top of the Black Creek formation.

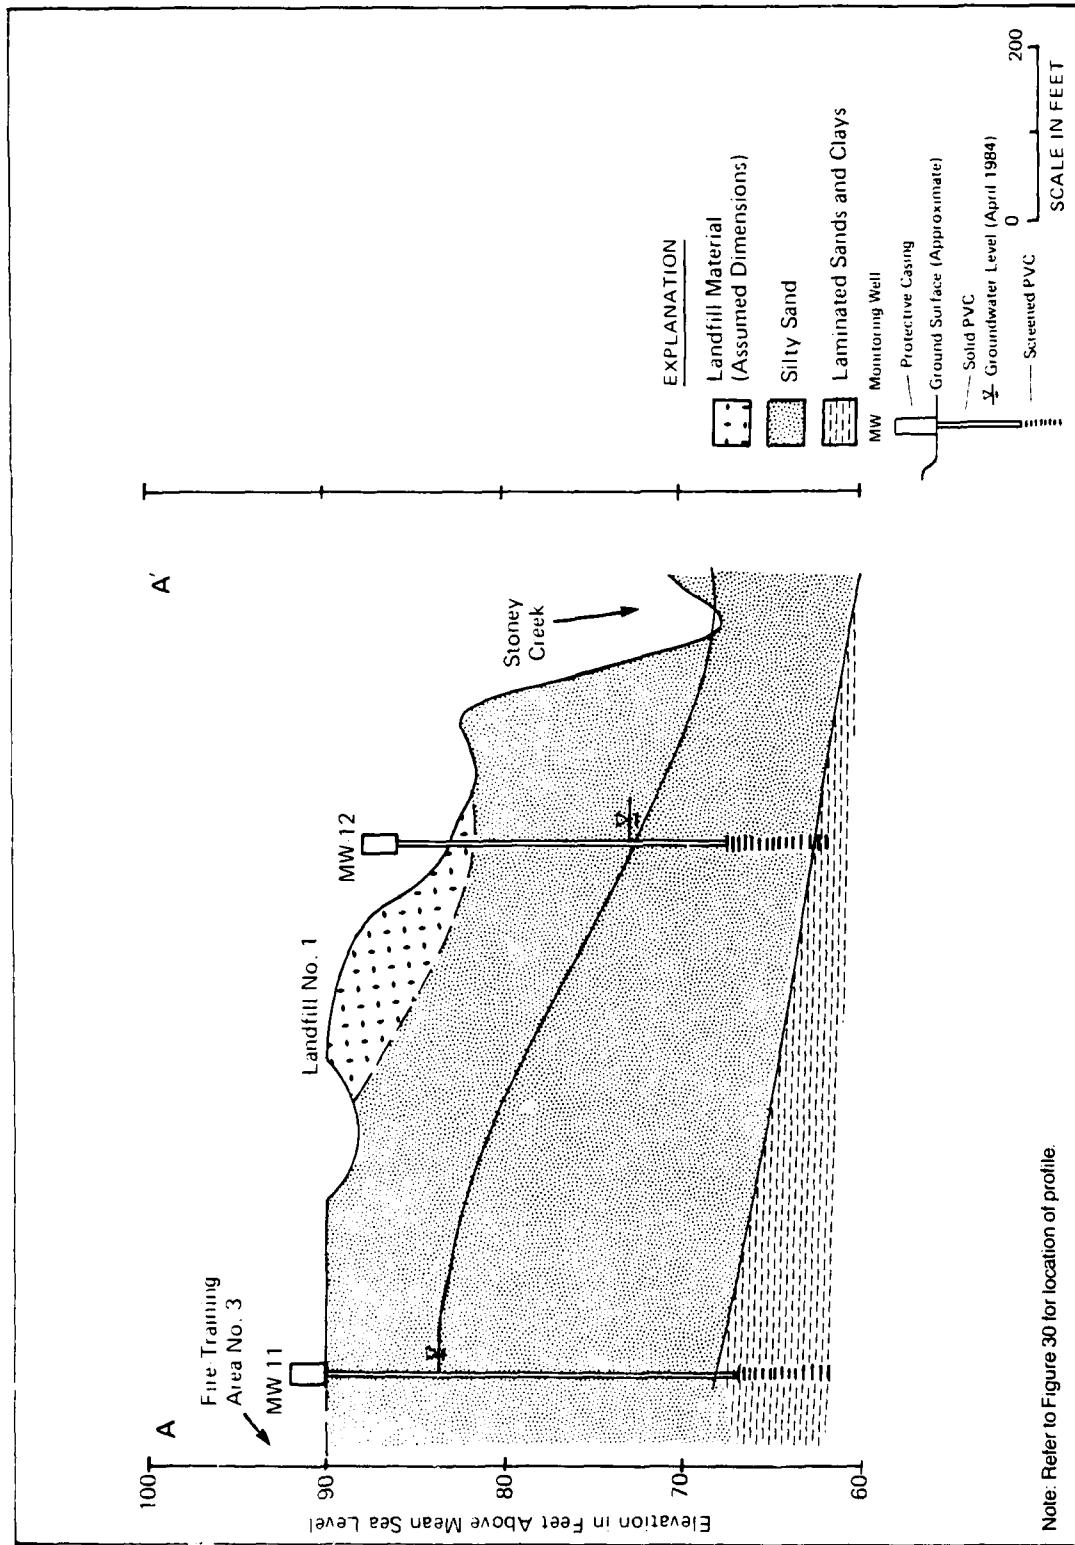
Figure 31. Inferred hydrogeologic profile A-A' (Site 6).

One monitoring well (MW-11) was installed just northwest of the fire training area. The inferred hydrogeologic profile has been constructed on the basis of data from this well and the well at Landfill No. 1 (Figure 31).

Well MW-11 is screened just below the sand strata within the Black Creek (Figure 31). The well had one of the lower yields estimated at the base and was not able to sustain a yield during development (Appendix F).

Groundwater was encountered at a depth of 5.83 feet below land surface in well MW-11 in early April 1984, a rise of just more than a foot since February 1984. This shallow water level is expected to be comparable with water levels in the overlying sand strata considering the proximity of the well screen to those strata (Figure 31). Groundwater flows from the fire training area where discharge ultimately occurs in Stoney Creek. This relationship is inferred in Figure 31.

Well MW-12 is screened just above the top of the Black Creek formation (Figure 31). The well had an estimated yield (less than 10 gal/min) consistent with the texture of the fine- to medium-grained sands (Appendix F). The depth to groundwater was 9.55 feet below land surface in early April 1984. The direction of groundwater flow is likely to the northwest where discharge occurs into Stoney Creek (Figure 31).

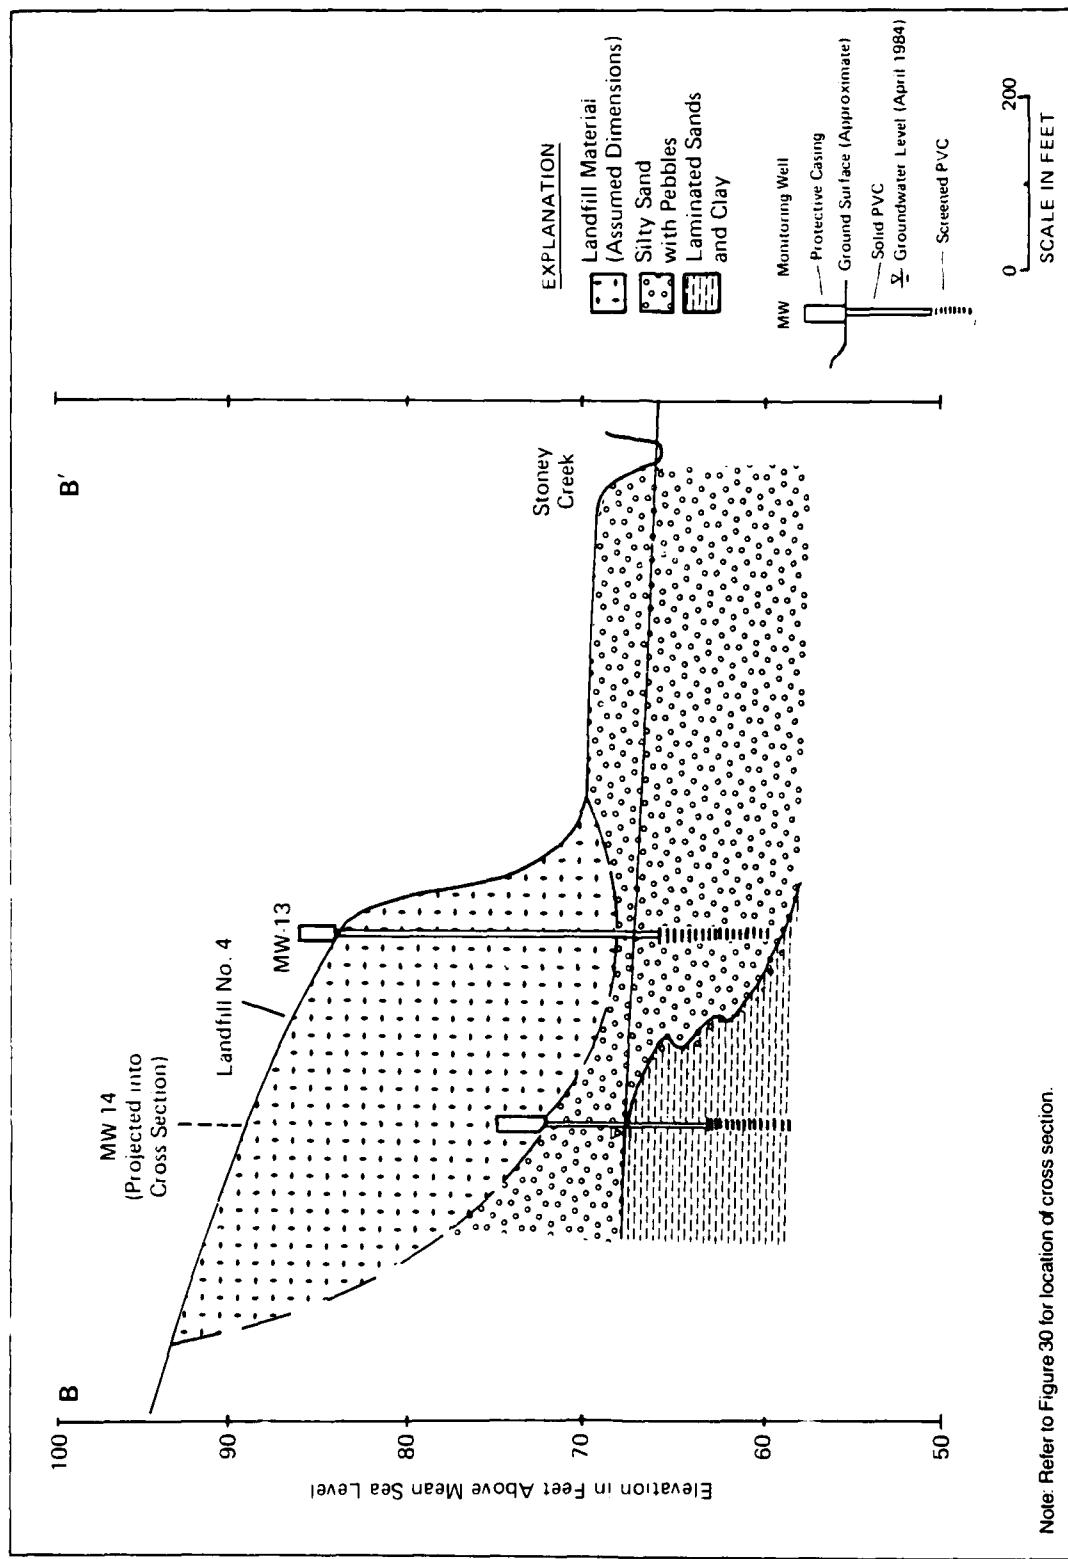
Figure 32. Inferred hydrogeologic cross section B-B' (Site 6).

The general topographic setting of Landfill No. 4 is indicated in Figure 30 along with the location of an inferred hydrogeologic cross section. The present surface of the landfill is fairly flat with a slope to the northwest. The northwestern limit of the landfill is marked by an abrupt scarp as the landfill extends onto a flat-lying plain near Stoney Creek (Figure 32).

Well MW-14 is screened within the Black Creek formation, and well MW-13 is screened within the sand strata (Figure 32). The depth to groundwater beneath the land surface varies significantly between wells MW-14 and MW-13 (4.82 and 17.05 feet, respectively) as a function of the thickness of fill encountered. Even though the wells are screened in different lithologies, the groundwater elevations are believed to be generally comparable. Groundwater flow is interpreted to be toward Stoney Creek with low hydraulic gradients (Figure 33). Well yields in both wells are estimated to be less than 1 gal/min (Appendix F).

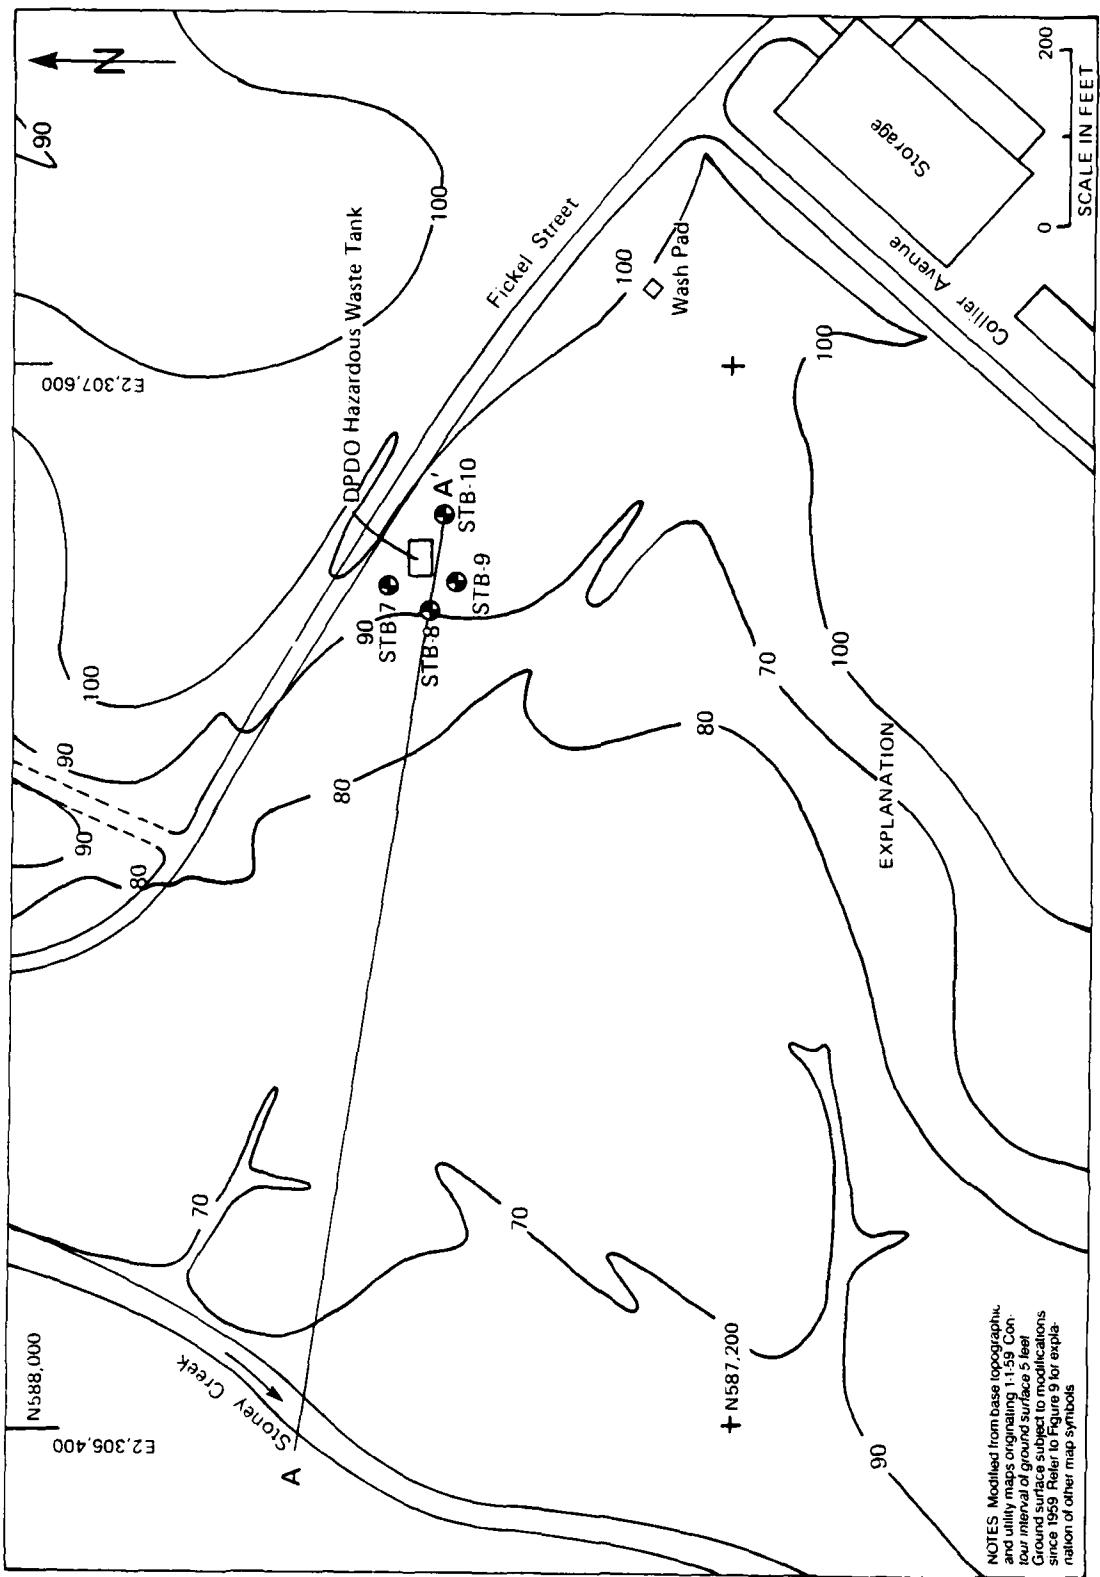
Figure 34. Topographic setting of Site 7 with location of inferred hydrogeologic profile A-A'.

The general topographic setting of Site 7 is indicated in Figure 34 along with the location of an inferred hydrogeologic profile. In the

immediate vicinity of the site, the ground surface is relatively flat. Evidence that some of this area has been filled is revealed by the soil test borings drilled at the site. To the southwest, the site area slopes steeply for a few hundred feet and then reaches the wide, flat-lying plain occupied by Stoney Creek (Figure 34).

Four soil test borings were drilled around the site to depths of 30 feet. Soil samples were retained for analysis but no monitoring wells were installed. Boring STB-10 was drilled slightly upgrade of the tank in an area assumed to be out of the direct influence of site activities. The remaining three borings were drilled just downgrade of the site (Figure 34).
